# UNDERWATER BRIDGE INSPECTION REPORT

STRUCTURE NO. 2796

10<sup>TH</sup> AVENUE

MISSISSIPPI RIVER

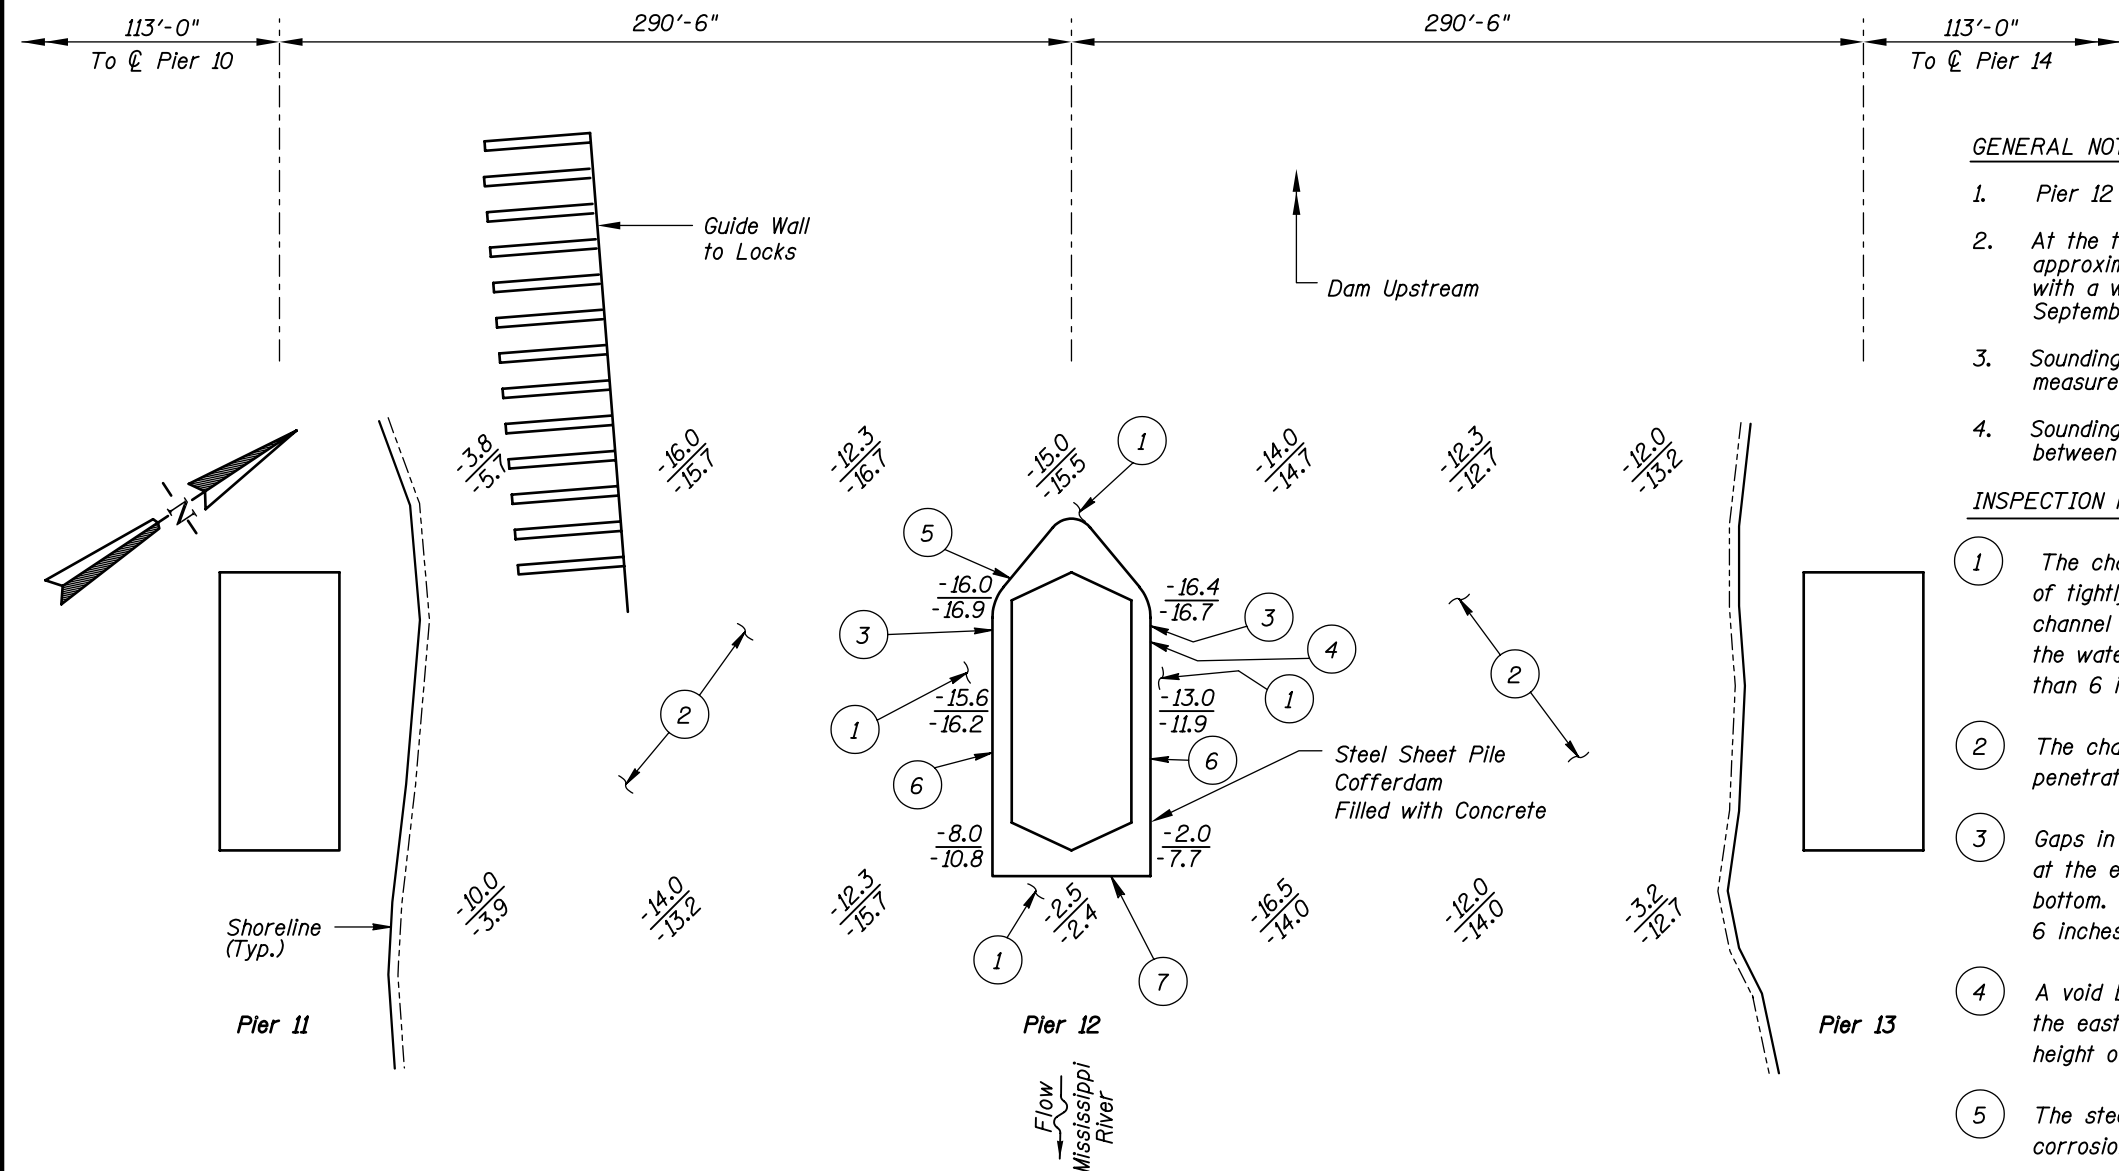
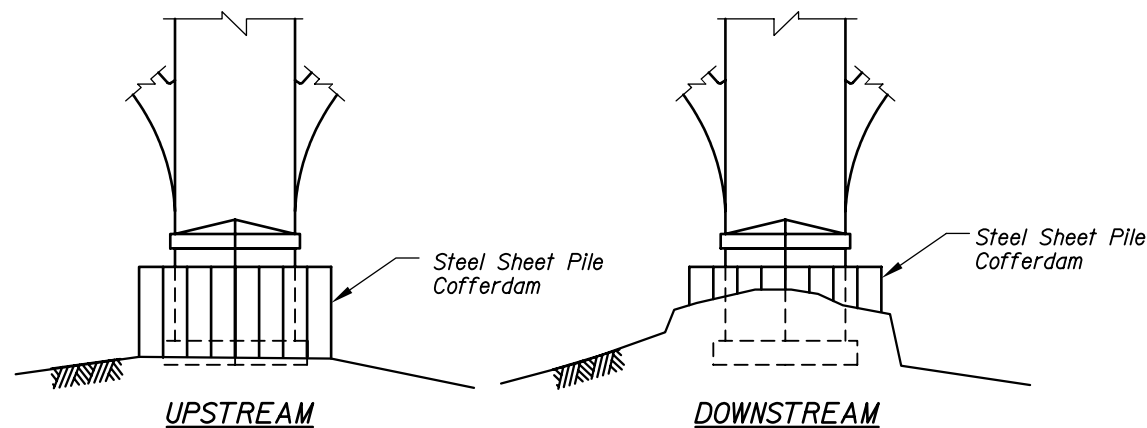
#### INSPECTION AND SOUNDING PLAN

- 1 The channel bottom material, within 10 feet of the substructure unit, typically consisted of tightly packed riprap from 1 foot to 3 feet in size. Along the downstream end, the channel sloped up at a steep angle and was located approximately 2.4 feet below the waterline, the downstream channel bottom material consisted of cobbles of less than 6 inches in size and riprap from 1 foot to 4 feet in size.

- 2 The channel bottom material consisted of a sandy gravel with 4 inches of probe rod penetration.
- 3 Gaps in the lines of construction (not at interlocks), were observed in the steel sheeting at the east and west upstream 1/4 points with maximum widths located at the channel bottom. The west gap measured 15 inches in width and had a maximum penetration of 6 inches. The east side gap measured 36 inches in width and had no penetration.

- 4 A void between the horizontal C-channels and the vertical sheeting was observed at the east side upstream 1/4 point of the pier at 2.5 feet below the waterline with a height of 2.5 feet and 2 feet of maximum penetration.

- 5 The steel sheeting was in good condition with a uniform 1/8 inch layer of surface corrosion extending from the top of the sheeting to the channel bottom.

- 6 The steel sheet piling was slightly separated from the concrete around the base of the pier for a length of approximately 20 feet along the east and west sides.

- 7 There was a hole in the steel sheet piling at the downstream end measuring 1 inch in diameter.

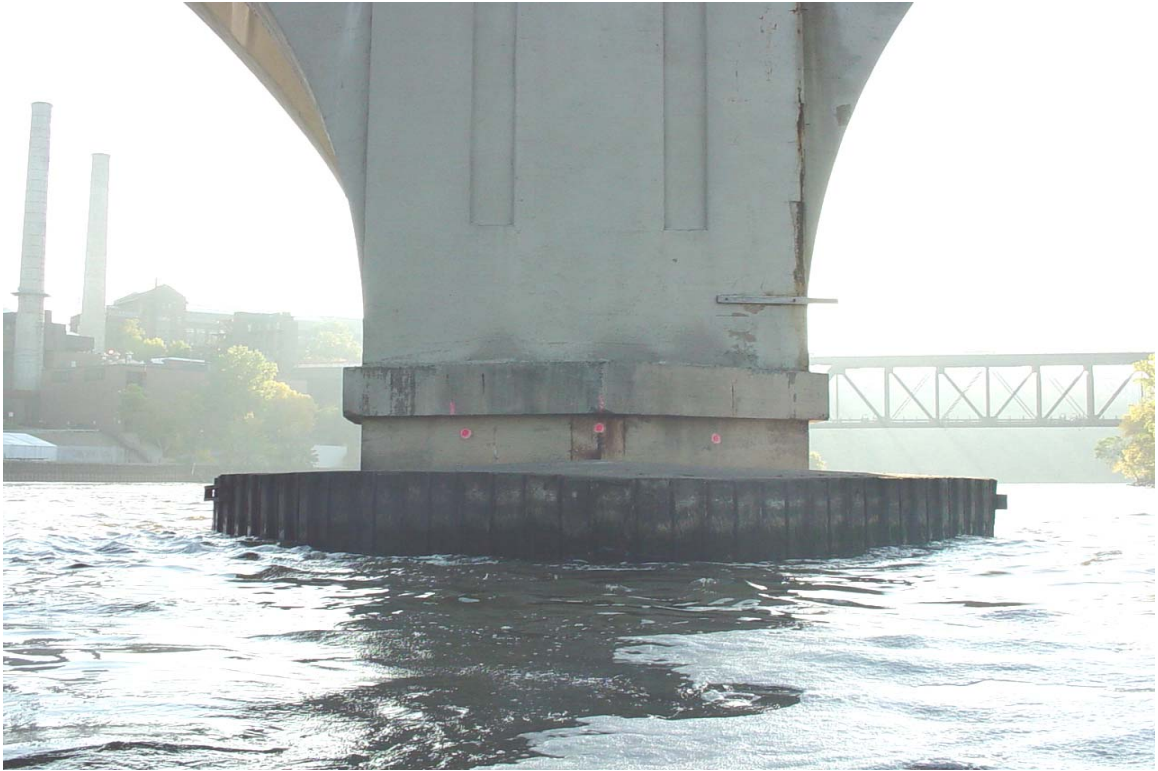
Photograph 1. View of the Upstream Nose of Pier 12, Looking East.

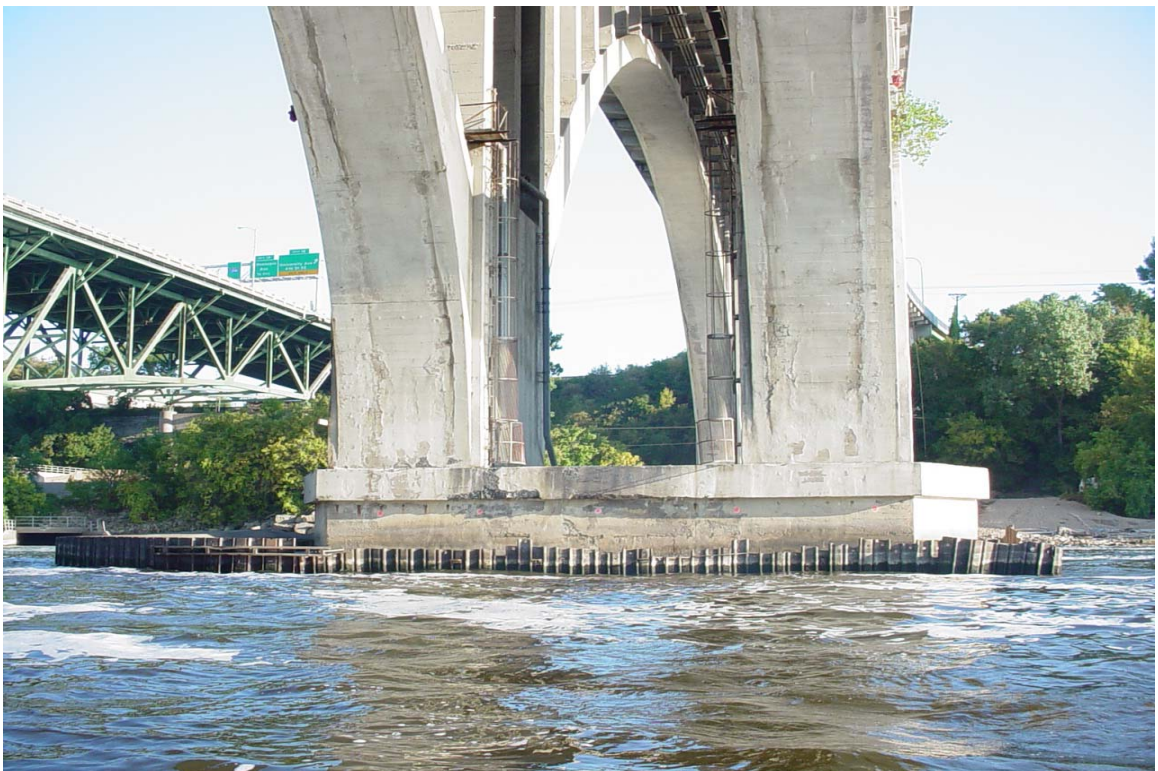
Photograph 2. View of the South Side of Pier 12, Looking Northwest.

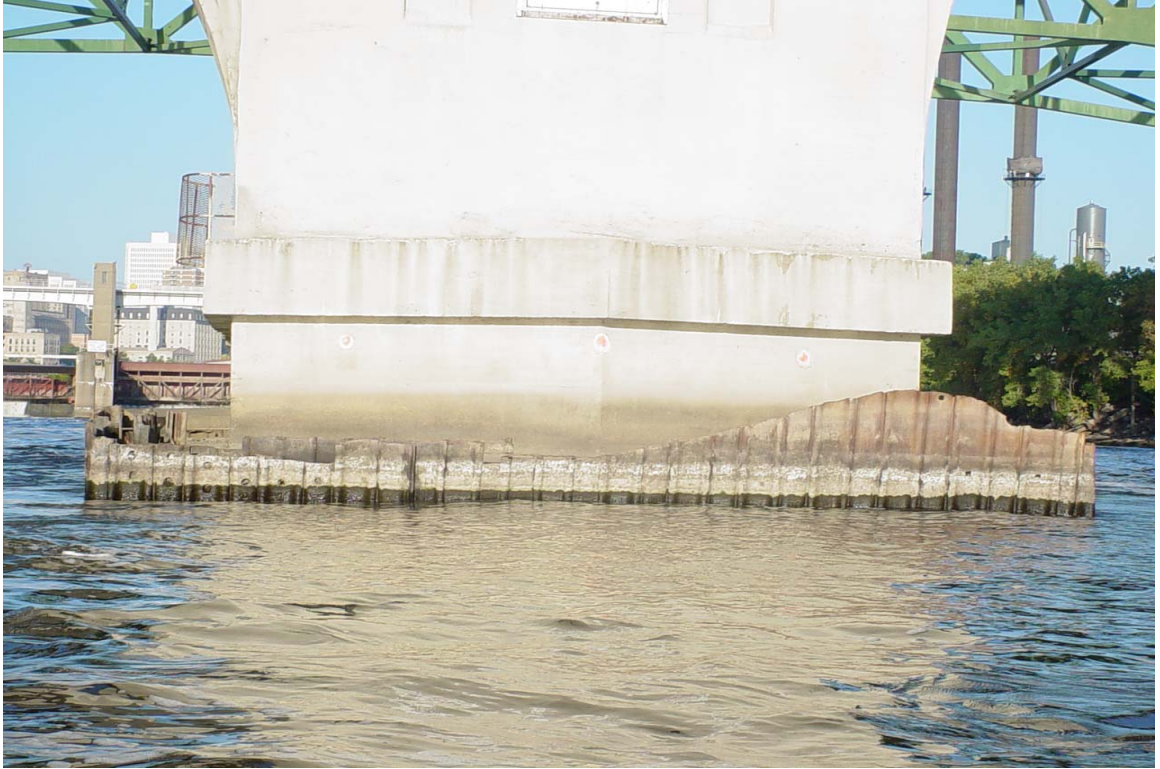
Photograph 3. View of the Downstream Nose of Pier 12, Looking West

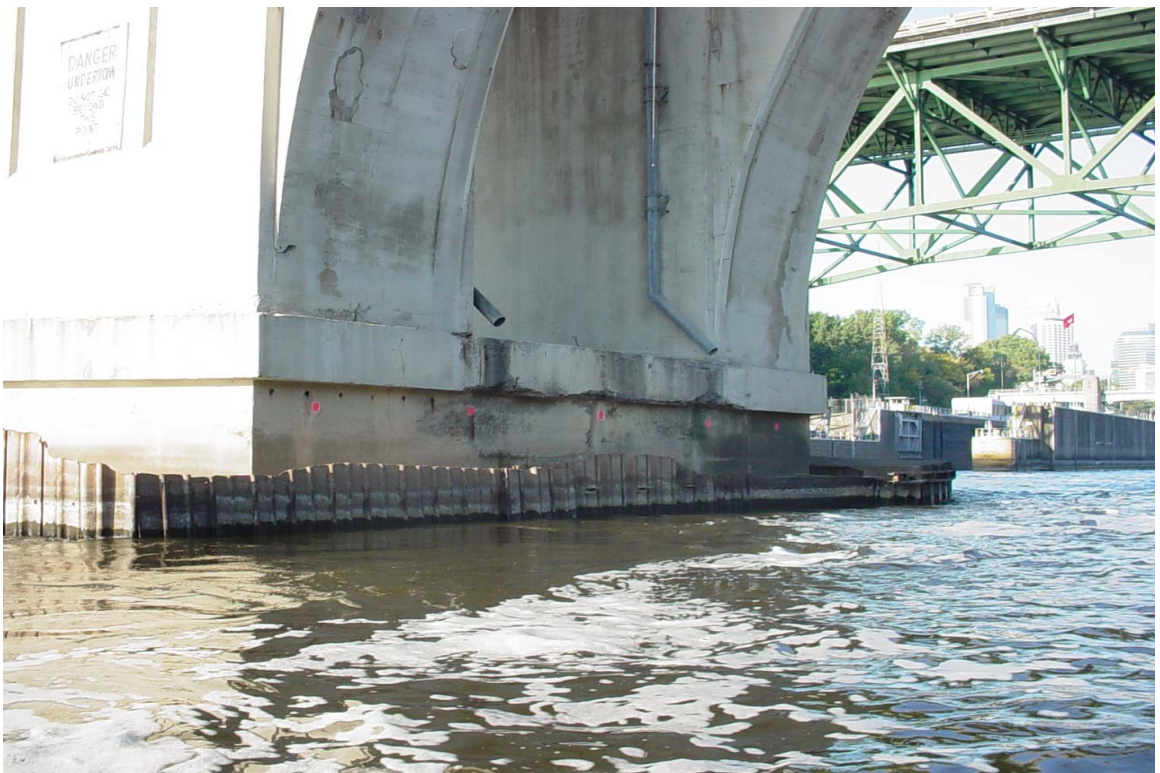
Photograph 4. View of North Side of Pier 12, Looking Southwest.
